June 2009

Remobilisation of Lead and Nickel Residues in Esperance

Report of the Working Group to the Steering Committee of the Esperance Cleanup and Recovery Project

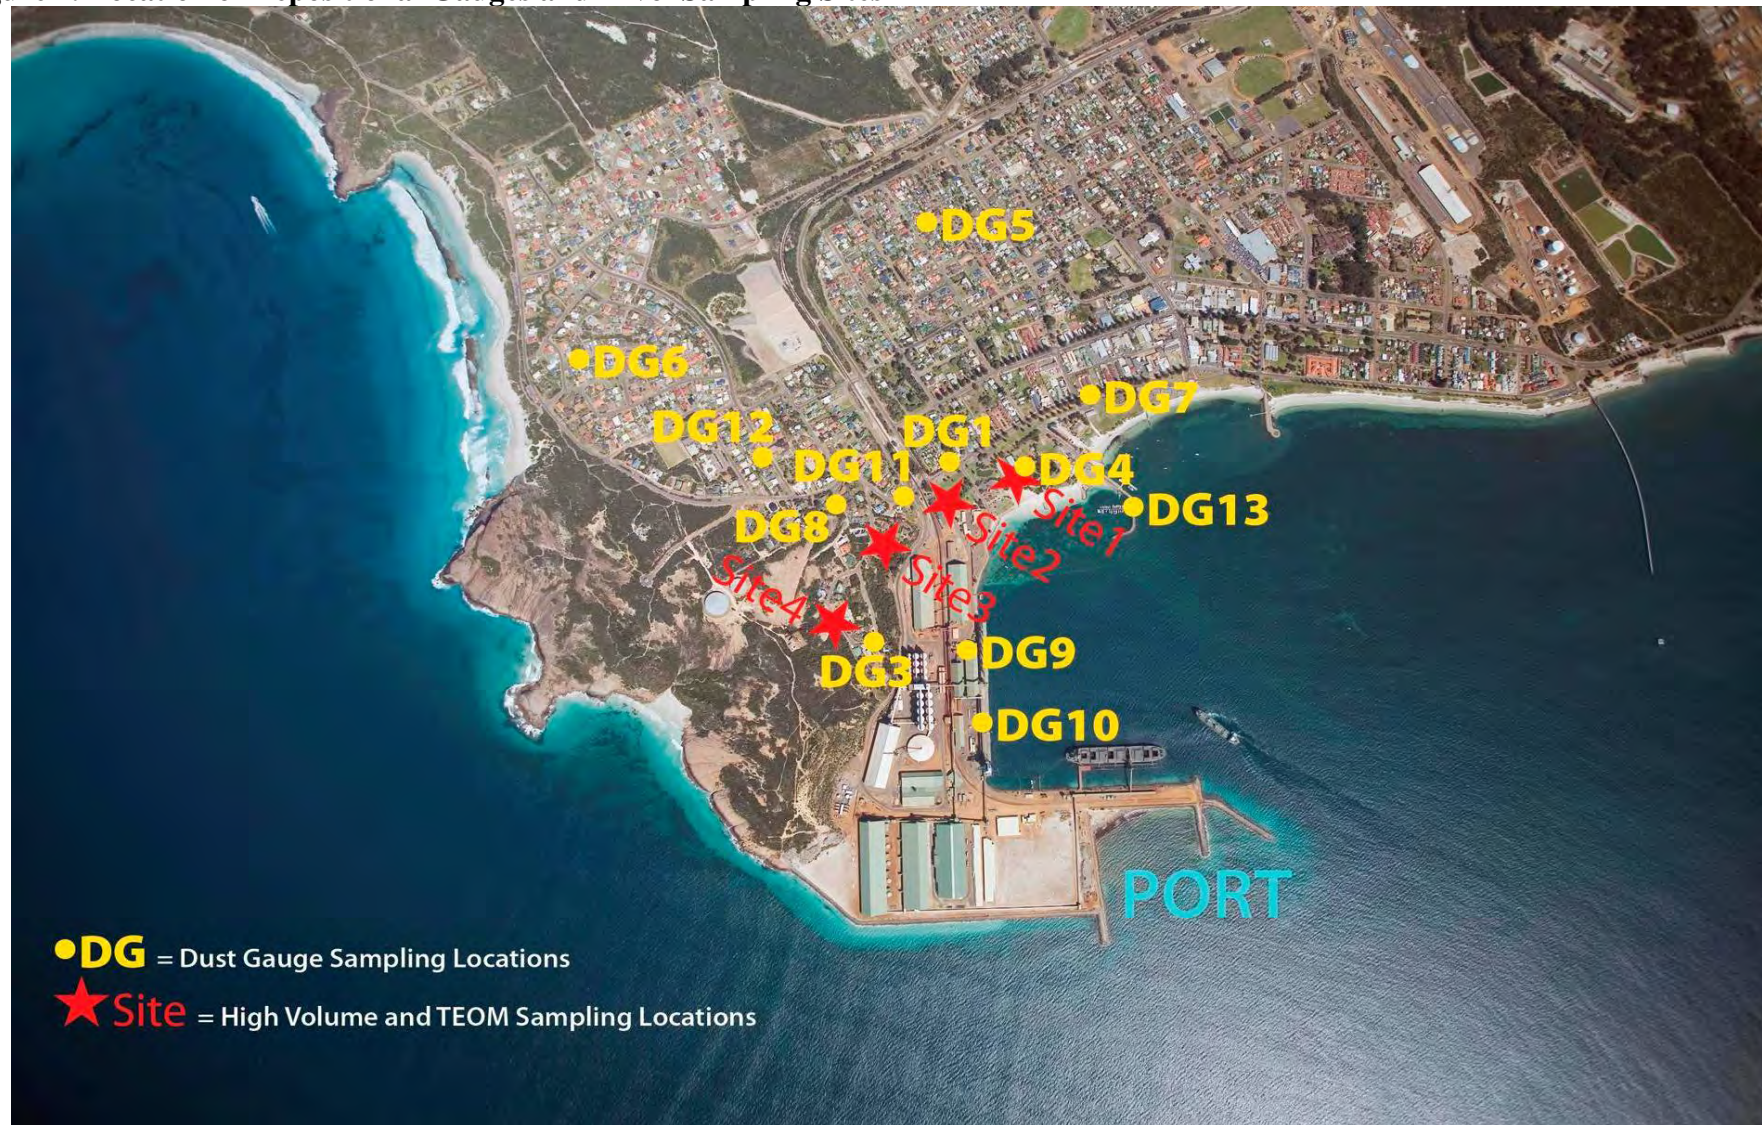
Figure 1. Location of Depositional Gauges and Hivol Sampling Sites

There is a vast amount of historical data available, but the focus of the study is “to determine if lead and/or nickel residues in the Esperance townsite are being mobilized”, so the most recent data are of the greatest relevance. Figure 1¹ shows the location of the depositional gauges (DG1 to DG13).

Figure 1 shows the location of four of the samplers (Site 1 to Site 4). Sites 1 and 2 are within the port boundary, Sites 3 and 4 in the community. A temporary site, Site 5, within the community adjacent to the port sheds, was installed in association with the removal of the lead concentrate stockpiled in the shed. A further three sites within the community are planned.

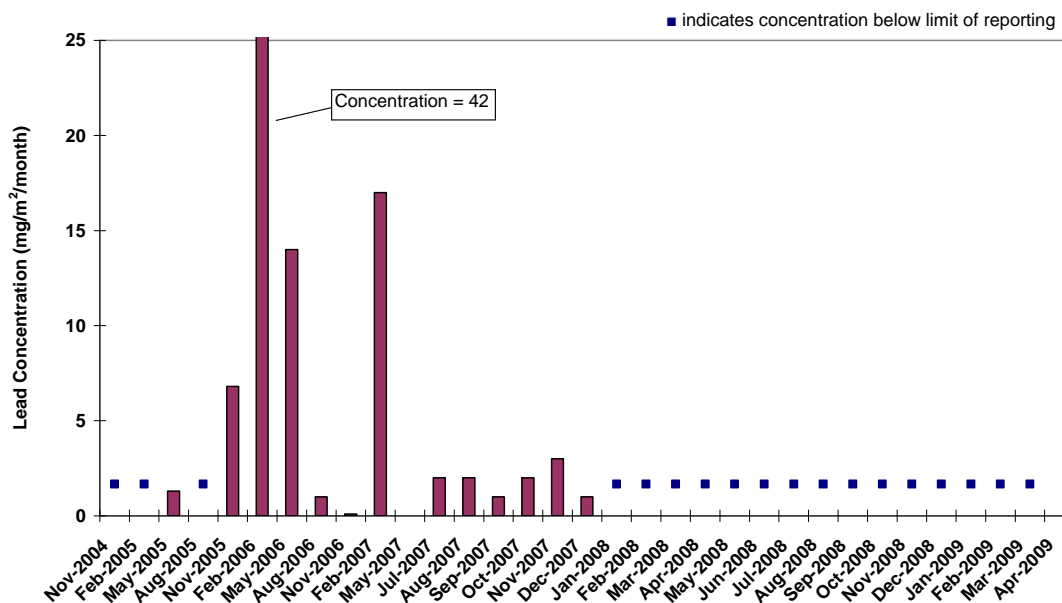
Figure 2. Lead Deposition on Gauge DG4 at Esperance

The depositional gauges were in place some months before lead export commenced and at that time both DG4 and DG8 showed concentrations below the level of detection, indicating a low background level of atmospheric lead in the town. During the period when lead was being exported some quite high levels of lead were recorded.

The export of lead concentrate ceased in March 2007 and no further high levels of lead were recorded at either site. Both sites recorded a low peak during October to December 2007, when EsPA was undertaking cleaning activities that appear to have remobilized some lead dust. While the levels recorded were lower than historic levels

(less than 3mg/m³) they indicate the sensitivity of the equipment to events leading to the possible mobilization of residues.

Since January 2008, a period of sixteen months, no lead dust has been detected at either site. This suggests that, during that time, regardless of seasonal effects like the wind direction or the presence of moisture, lead dust has not been remobilized in the ambient air in the townsite. Appendix 2 shows that the other sites tell a similar story.

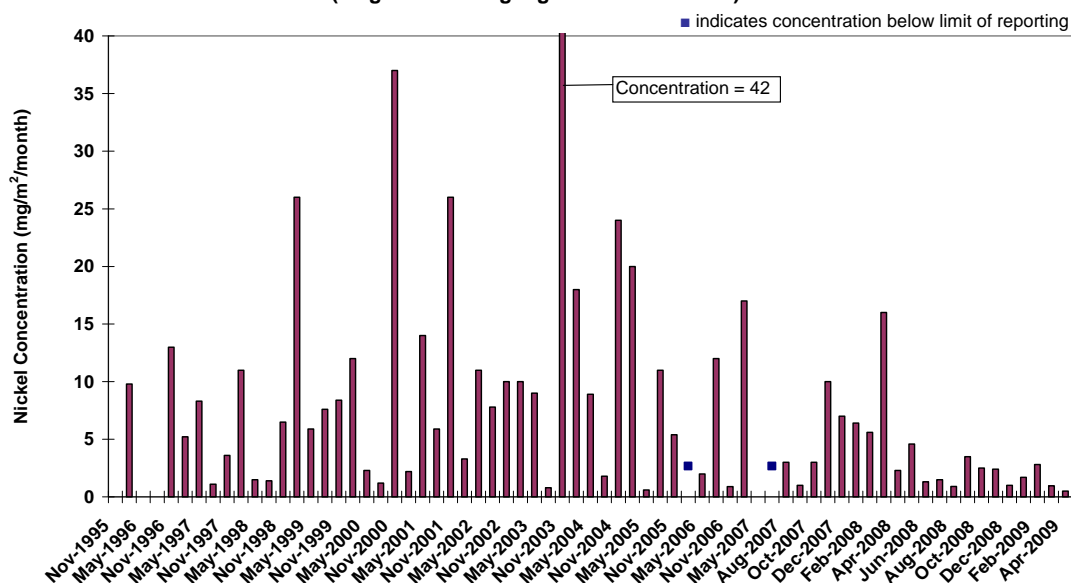
**Figure 4. Nickel Deposits on Gauge DG1 at Esperance
 (neighbourhood gauge close to the Port)**

Figure 4⁴ shows the levels of nickel found in dust at DG1, located within the townsite but close to the port and its ongoing nickel export activities. Of greatest relevance to

the present study is the ongoing recording of nickel dust, albeit at a reduced level since mid-2005. While this indicates an ongoing ambient level of nickel dust, it is impossible to say from these data whether this is due to remobilization of existing residues or whether it is new dust arising from the ongoing nickel export.

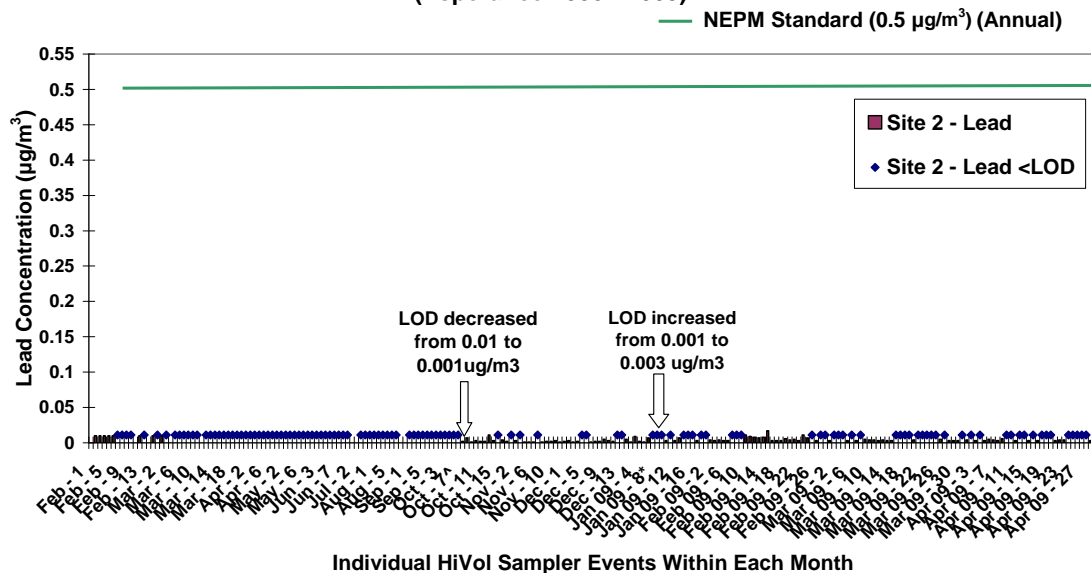
Figure 6. Lead Levels at Site 2 High Volume Air Sampler
 (Esperance 2008 - 2009)

Figure 6⁷ shows the lead levels recorded at Site 2, in the community but adjacent to the port. Over the 15 months from February 2008 to April 2009 inclusive virtually no lead was detected in the sampler. Of the ~200 readings taken in that period three quarters found no lead (i.e. if lead was present in the sampled air it was below the analytical laboratory's level of detection⁸) and the rest found only traces of lead. These findings are supportive of the conclusion that during that period lead dust has not been remobilized in the ambient air in the townsite.

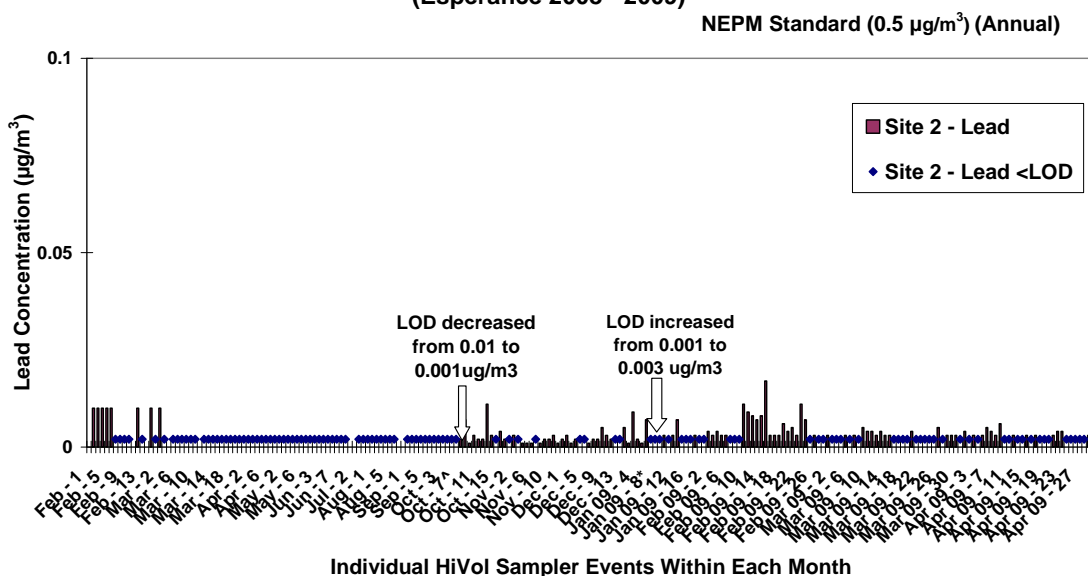
**Figure 6a. Lead Levels at Site 2 High Volume Air Sampler
 (Esperance 2008 - 2009)**

The low levels of readings recorded are somewhat hard to read because they are so much lower than the standard of $0.5\mu\text{g}/\text{m}^3$. In Figure 6a the lower portion of the chart has been expanded to make these small readings more visible. However, the comment in 2.1, above, recommending caution in the interpretation of readings close to the limit of detection applies.

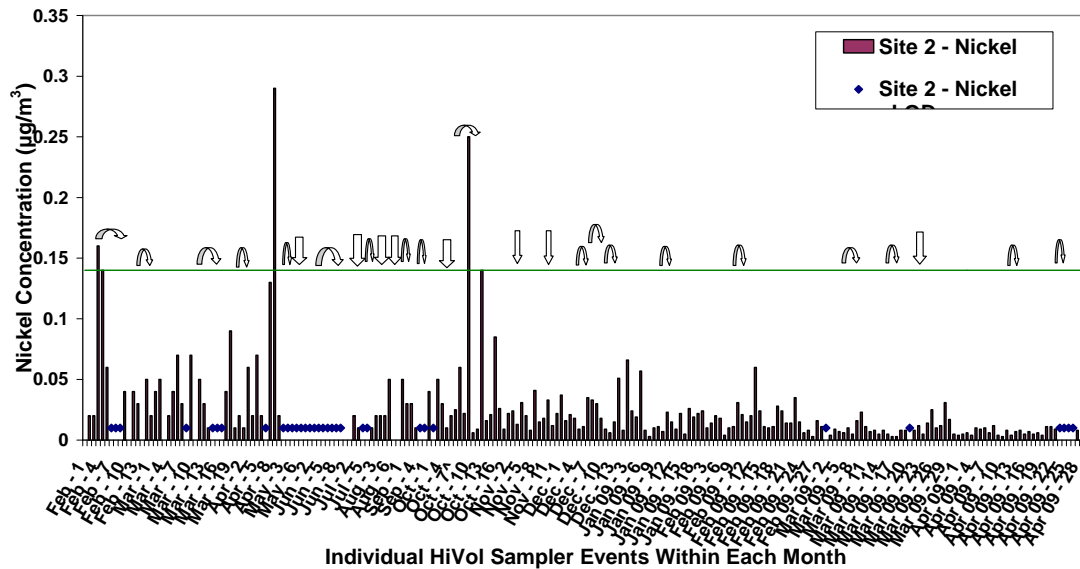
Figure 7. Nickel Levels at Site 2 High Volume Air Sampler (Esperance 2008 - 2009)

Figure 7⁹, which also relates the community site, Site 2, shows nickel levels recorded over the same period (February 2008 to April 2009). The chart also shows the periods during which ships were being loaded and the daily target nickel level of $0.14 \mu\text{g}/\text{m}^3$ set in EsPA's environmental licence to be protective of acute health effects. Again some samples recorded nickel below the level of detection, including during some loading events. On three occasions the target level was exceeded, on eight occasions peaks of between 0.05 and $0.1 \mu\text{g}/\text{m}^3$ were recorded during ship loading and lower quantities of nickel were detected at times when no loading occurred, for example, in the second half of February 2009.

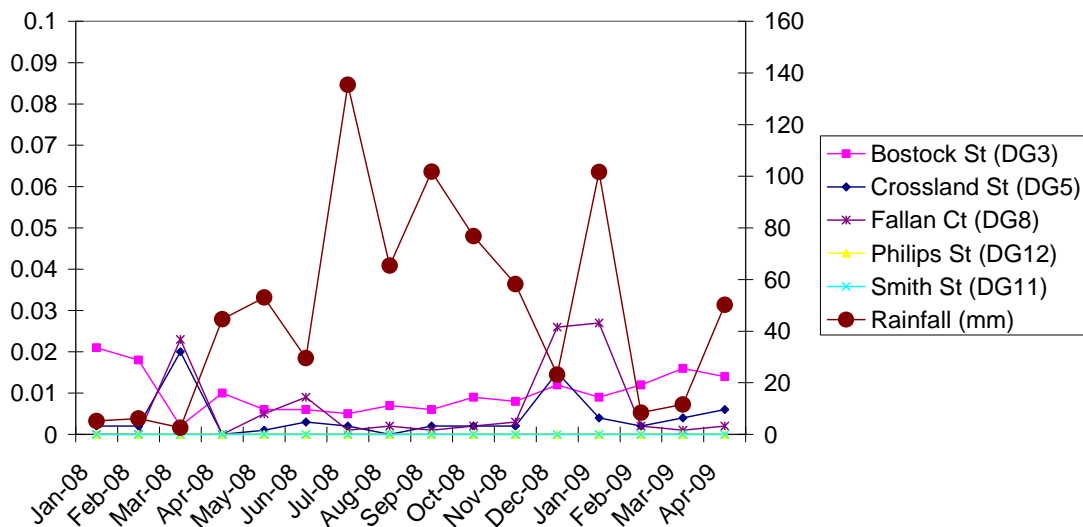
Figure 8. Rainfall vs. Lead Concentration in Rainwater Samples Near Esperance Port 2008
 (guidelines set at 0.01mg/L for drinking water)

Figure 8 presents DEC’s graphical comparison of the monthly measured levels of lead in rainwater tanks with the monthly rainfall data for Esperance. Three of the five sites recorded some readings in excess of ADWG (in contrast to three tanks in Albany which were all below ADWG). There appears to be no clear correlation between a high monthly rainfall and an increased level of lead. As noted in (i) above, it may be that the flushing of new lead dust from roofs is counterbalanced by dilution with the additional rainwater. The data presently collected cannot resolve the question and it is doubtful, given the many confounding factors, if extended rainwater sampling would provide a clear answer.

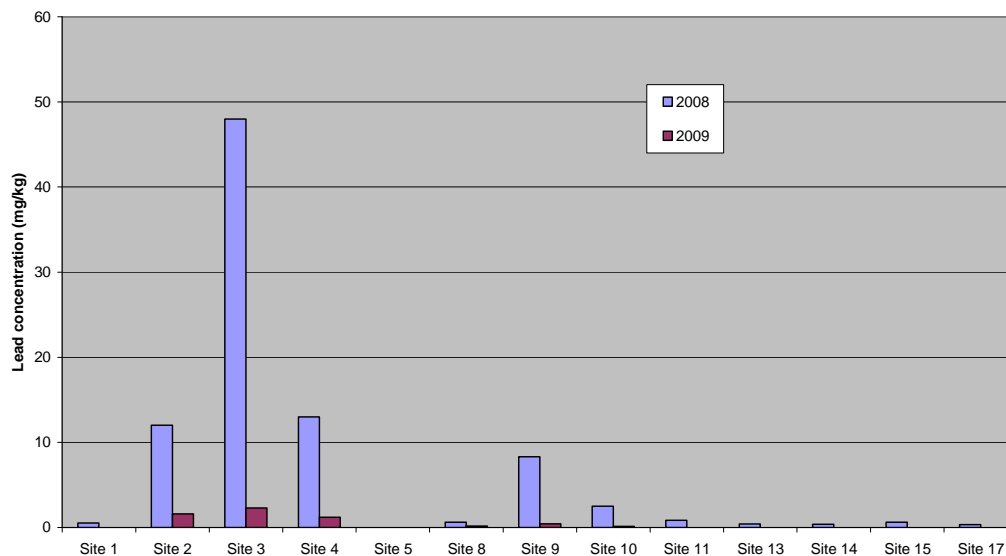
Figure 9. Lead Concentration Changes in Flowers from plants at sites across Esperance in 2008 and 2009

The 2009 re-sampling provides evidence of whether lead is still being “deposited onto new growth leaves and flowers”. Figure 9¹⁶ presents a comparison of the data from the two surveys for flower samples. These plant samples, being the shortest-lived, should reveal any current remobilization of lead dust.

Sites 2, 3, 4 and 9, where the highest readings were recorded in 2008, are the monitoring sites closest to the port. It may be that the lead detected was deposited on those flowers during the October to December 2007 cleanup of the port. Figure 9 shows the 2009 lead levels to be substantially lower than in 2008, with levels below detection at several sites. This suggests there was little or no remobilization of lead dust onto flowers of the sampled plants during the 2009 flowering period. This is supported by data for lead levels in leaves of deciduous trees which were very low and similar to the levels found in Albany (see Appendix 5).

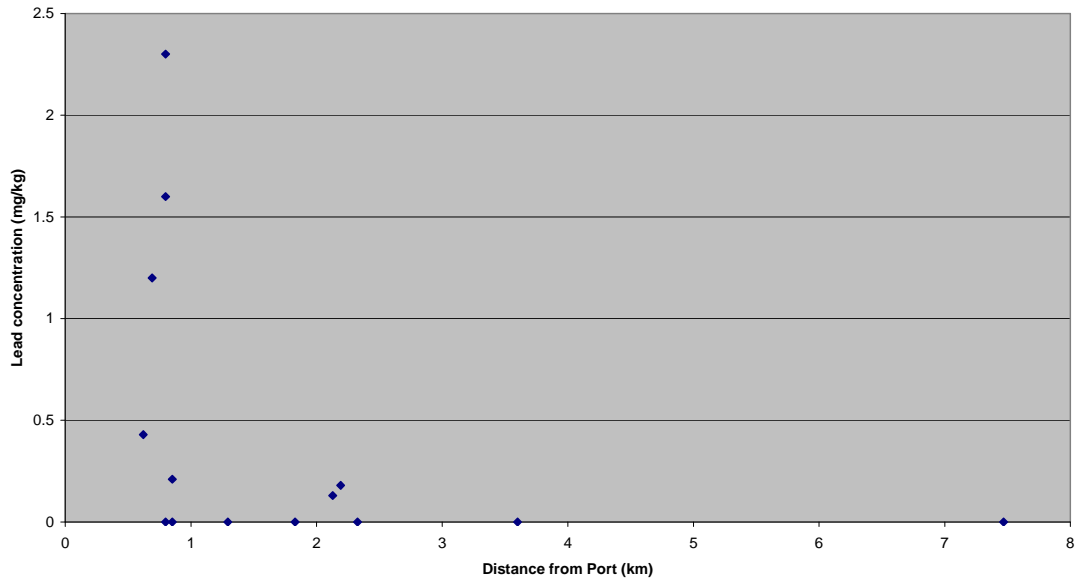
Figure 10. Lead in Flowers (2009) vs. Distance from Port

Figure 10 looks more closely at the 2009 samples plotting lead levels against distance from the port. Although the levels found are low (<2.5 mg/kg), it is clear that some of the sites within a kilometer of the port are recording levels of lead significantly above background, as measured by the site 7 km from the port. Given the absence of airborne lead, it is likely that this lead has been transferred from older accumulations on adjacent leaves.

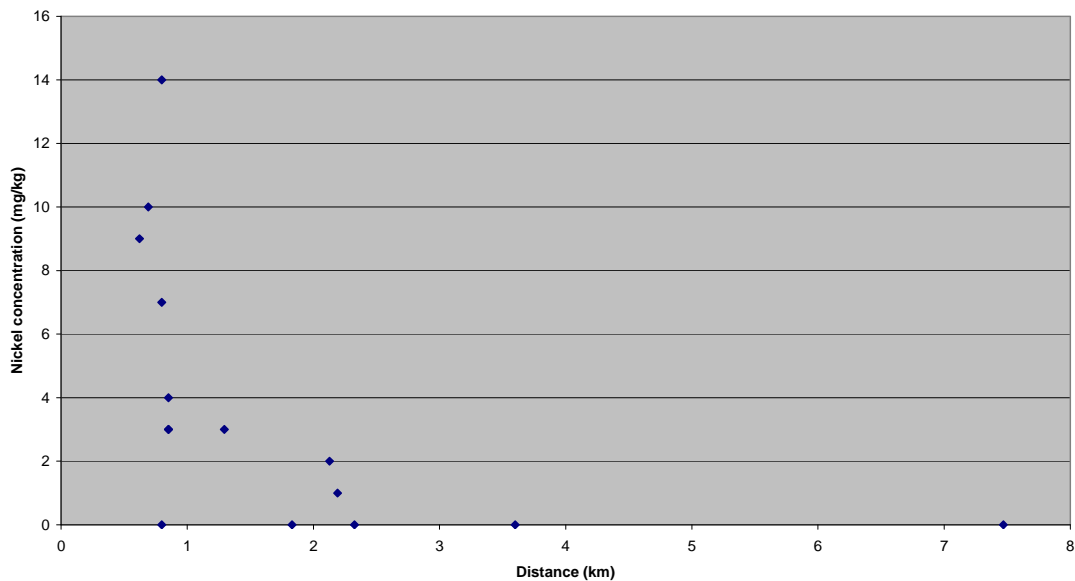
Figure 11. Nickel in Flowers (2009) vs. Distance from Port

Figure 11 presents the data for nickel. The results are similar, with levels close to the port low (up to 14 mg/kg), but still elevated above background. Findings for deciduous leaves (Appendix 5) support this.

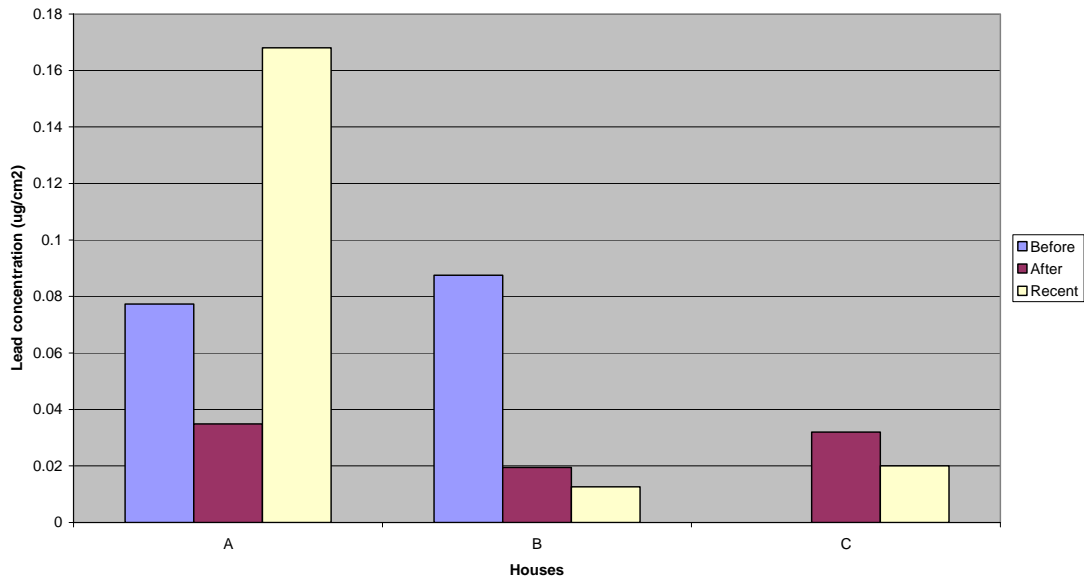
Figure 12. Internal Lead Levels in Cleaned Houses

Figure 12 shows the average lead levels found in internal swabs taken in three houses that were cleaned. Two were sampled before cleaning, and all three were sampled after cleaning in 2007 and again in 2009.

The results for House B are as expected with a high level prior to cleaning, a much lower level after cleaning, though while the port cleanup was progressing, and an even lower level a year later. For House A, however, the 2009 reading is elevated. A look at the data shows that two of the ten swabs were very high (0.8 and $0.6 \mu\text{g}/\text{cm}^2$) but the other eight averaged $0.02 \mu\text{g}/\text{cm}^2$. It appears that the two elevated swabs are exceptional. All other swabs suggest that cleaning has been effective and there has been no general recontamination. These two swabs, in the Master Bedroom and Lounge appear to be specific examples of micro-remobilisation, perhaps from foot traffic.

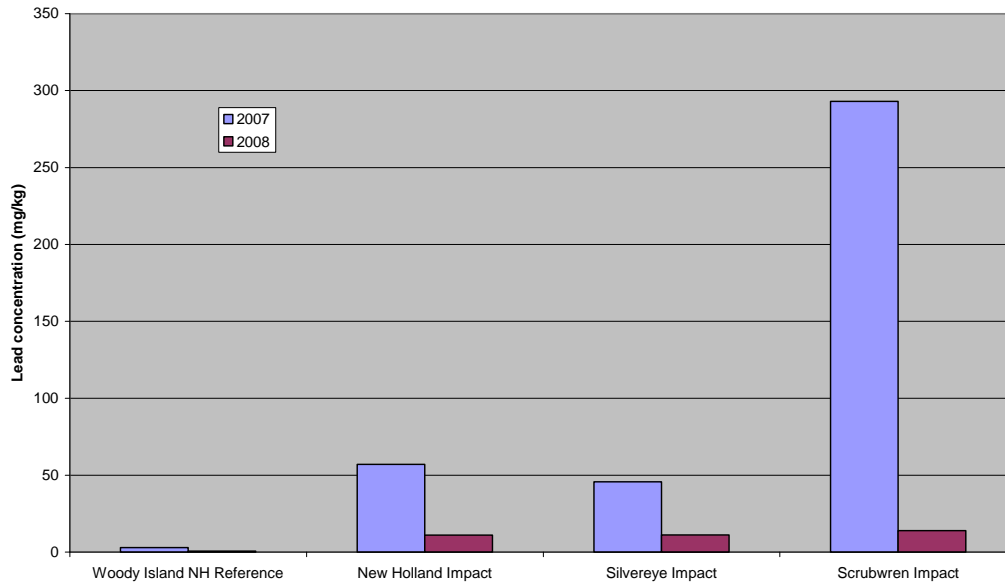
Figure 14. Lead in Bushbird Feathers 2007 and 2008

From the first survey Dunlop et. al. recommended “monitoring, and where feasible, remediation, needs to be continued until the Pb in Esperance bush birds has returned to background levels”. From the results of the second survey this point appears to have been almost reached.

A hypothesis for the second study was that the lead in the environment might concentrate in “hot spots” in litter or drainage sumps leading to incorporation into the food chain. Nick Dunlop³³ advises that results to date provide no evidence to support that hypothesis.

It seems that birds are mainly carrying the lead on their plumage. Despite preening involving the licking of feathers it appears that the lead is not being ingested, but is remaining bound (physically and perhaps chemically) to the feathers. Ten silvereyes were sacrificed and analysis found no relationship between lead in plumage and lead in liver.

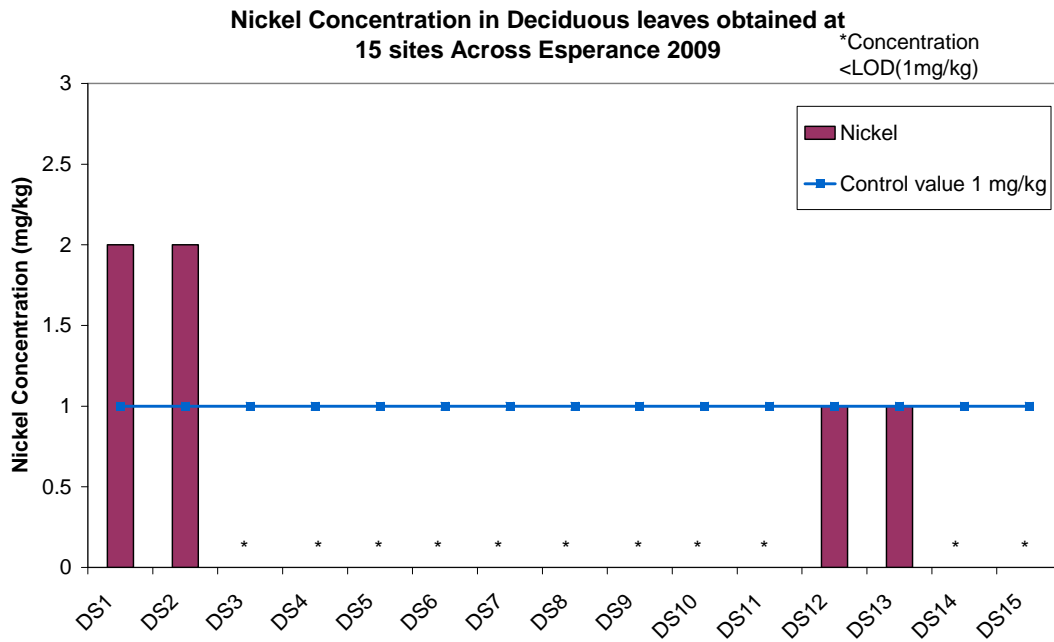
For nickel all sites were at or below the level of detection except DS1 and 2. These data do not provide evidence of mobilization of nickel in the wider community in 2009, with a low level of nickel detected only at sites closest to the port. Note that the LOD for nickel is five times that for lead due to analytical limitations.
